## SHEQ Workplace Audit Report

<b>Score</b>	121 / 136 (88.97%)	<b>Flagged items</b>	7	<b>Actions</b>	6
<b>Client</b>	Alpine F1				
<b>Conducted on</b>	13.06.2024 08:00 BST				
<b>Prepared by</b>	Gareth Wood				
<b>EPS site management present</b>	Karolis Dijokas / Dave Kettle

Alpine F1 ESO

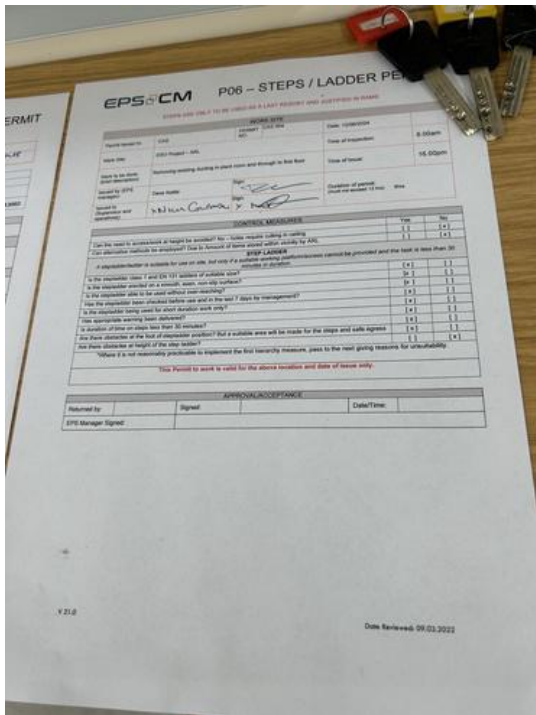
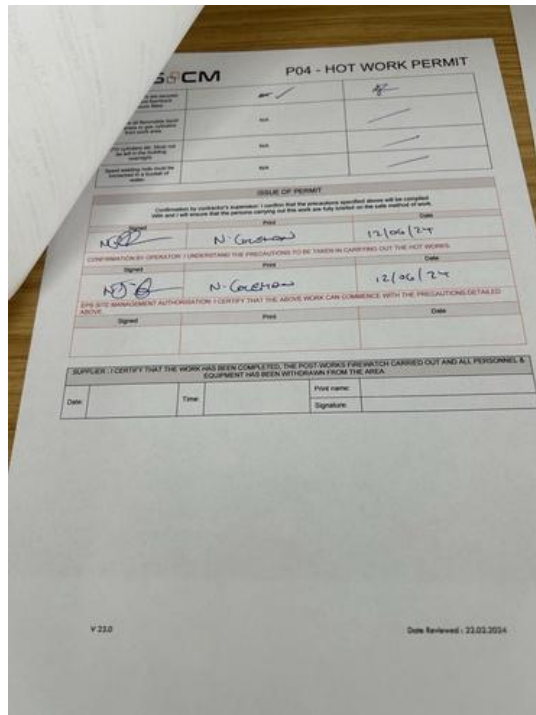
Hot works & ladder permit from 12/06 not closed out. No HW permit had been issued for grinding works on rebar area.

Suppliers are to ensure that requests for permits are carried out before they begin the high-risk works on site. Permits should also be closed out at the end of the working day, this is not only in relation to EPS procedure, but also relates to the requirements of Alpine's Hot Works procedure, dictated by their insurers.

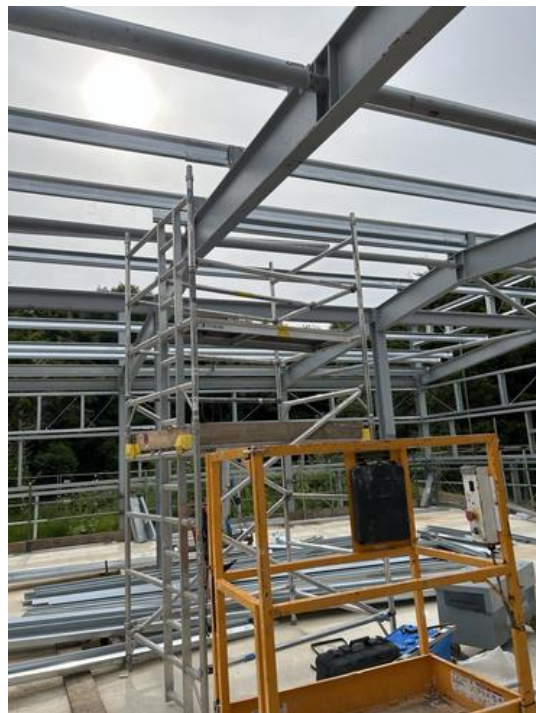
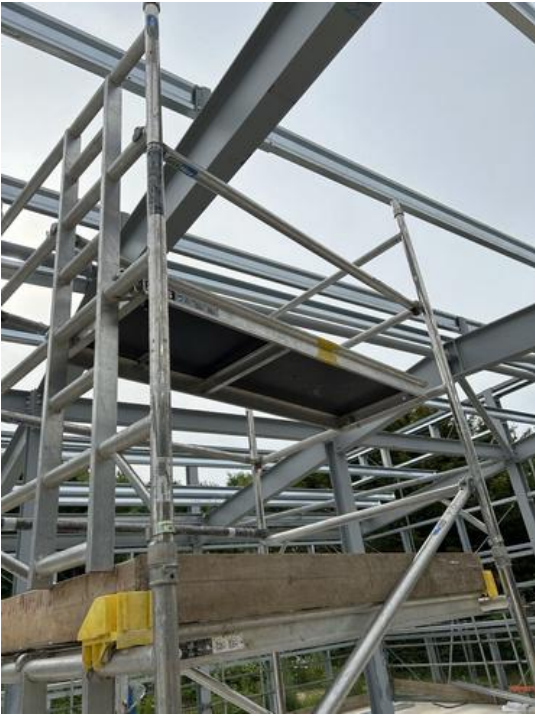
Mobile towers on site were incorrectly erected. Suppliers are to ensure all towers are compliant.

Suppliers are to ensure all their work equipment is used correctly and compliant to WAH regulations and PUWER.

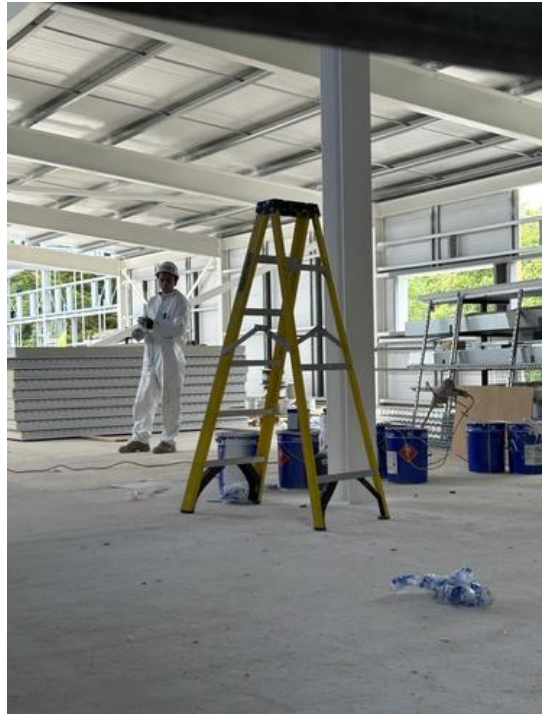
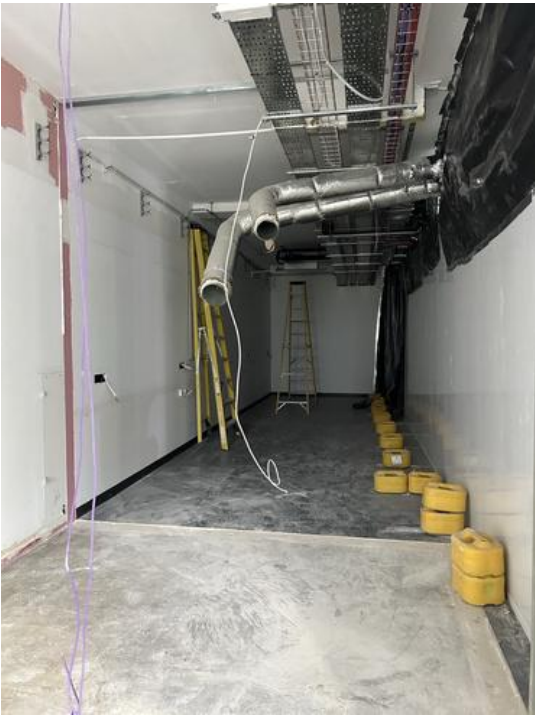
Ladders were in use on the project when other access equipment would be more suitable. When the IMS operative pictured was questioned on use of steps, he replied that these have been approved by his supervisor, Andrew King.

Step ladders were being used on the project without adequate justification and in the case of IMS, with no permit and therefore approval from EPSCM. All step ladder use is to be justified before they are even brought on to site.

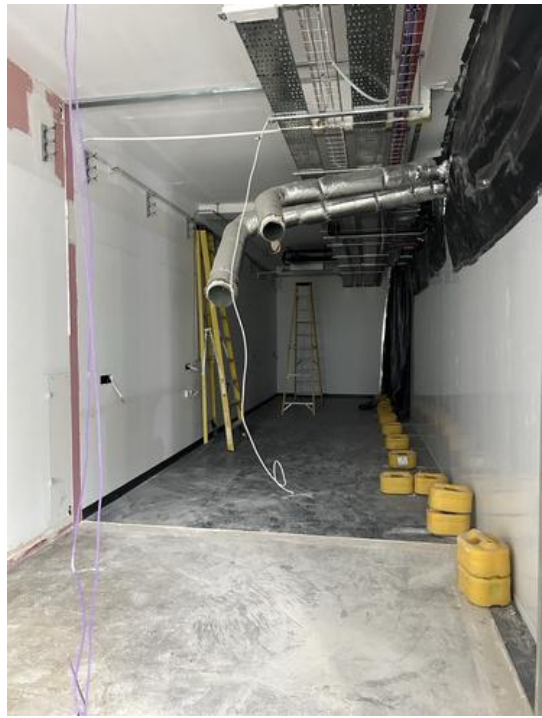
Photo 10

Ladders were seen on ground floor level of ESO building when towers or podiums could have been used.

As with previous point, ladder use is to be justified by EPS first.

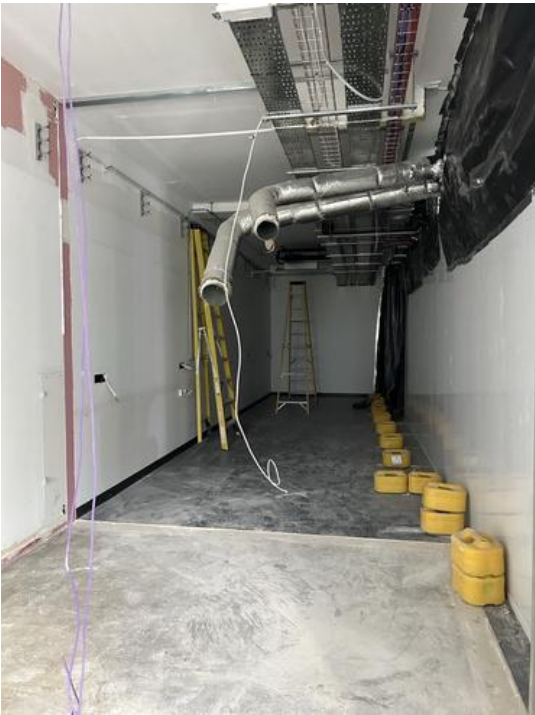
Photo 11

No ladder permit had been requested by any operatives using them on the project.

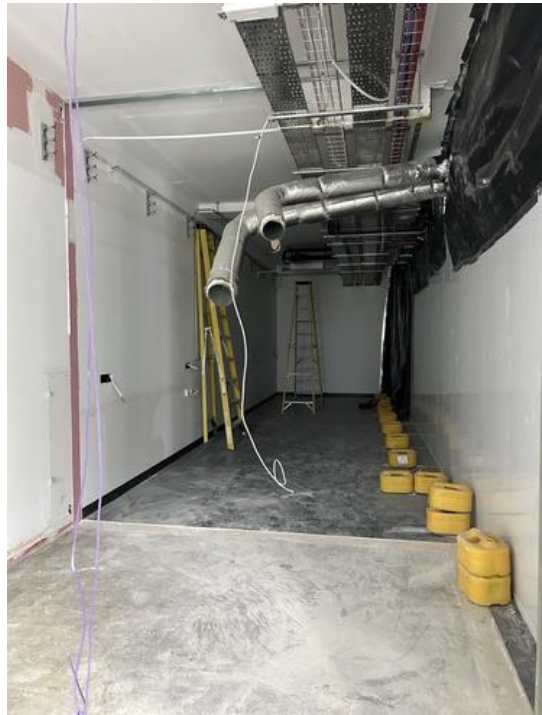
Photo 12

Ladders for in the picture above had no recent record of inspection.

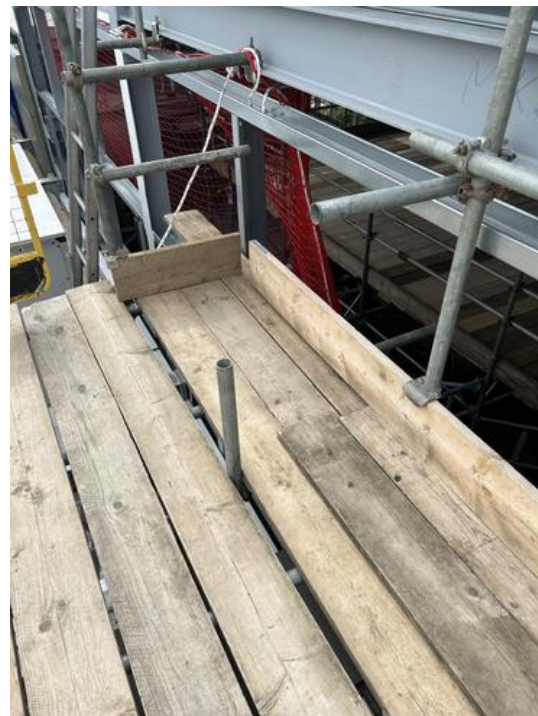
Photo 16

Scaffold bearer requires capping. This was identified on a non-scored visit last time.

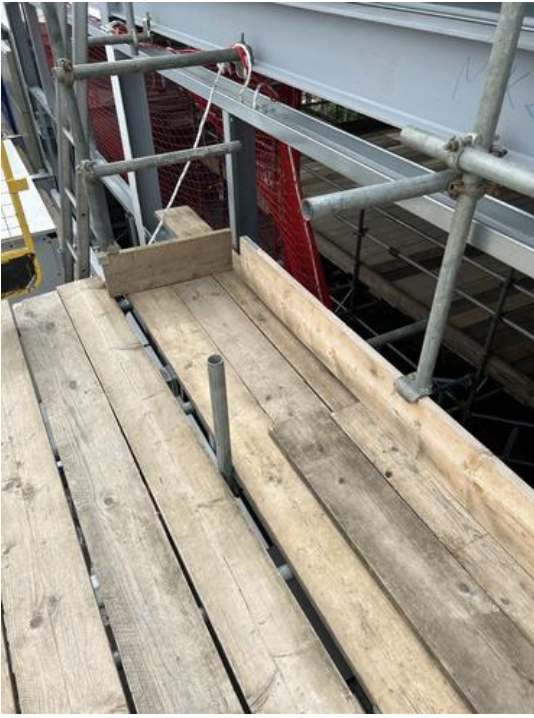
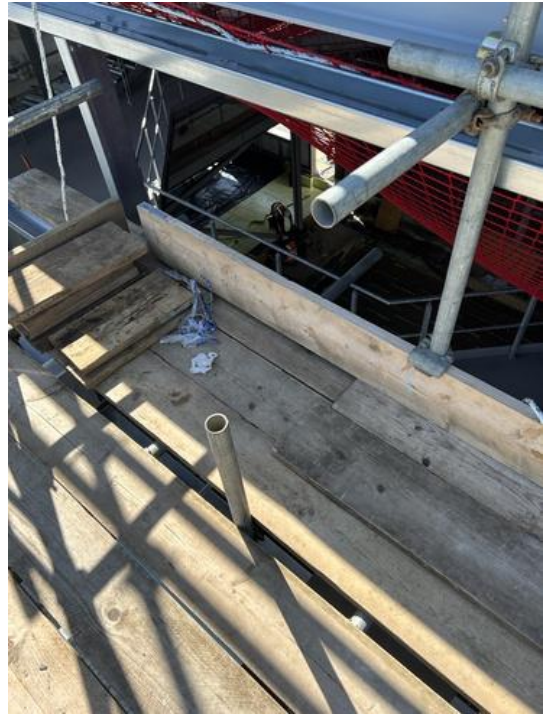
It was disappointing to see that the last time I attended site I identified that a bearer needed capping and had not been rectified. Photos above were taken today and on the last visit.
